# Access Compliance Report Public Rights-of-Way (Curb Ramps)

Main Street: ANGLER\_LN Cross Street: CHRISTY\_LN Location: SE

ADA ID: RPRK211209113500 Ramp Type: Type 1 - Perpendicular Diagonal Initial Pass/Fail: Fail Overall Compliance: No Severity Score: 16

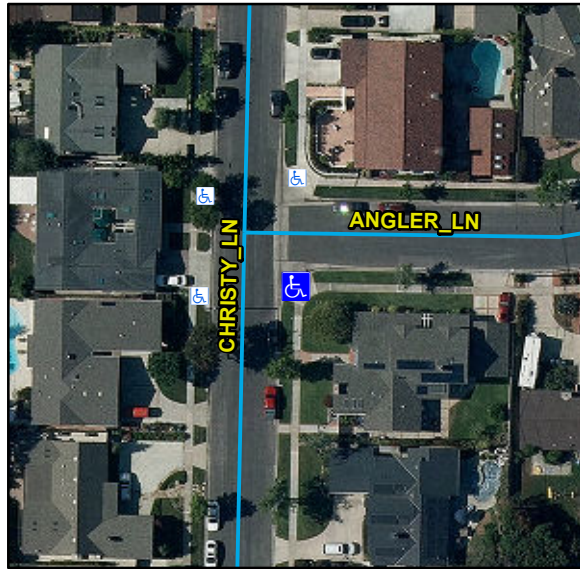
| Compliance | Description | Data | Compliance | Description | Data |
|---|---|---|---|---|---|
| No | Ramp Run Slope (%) | 9.7 | N/A | Flare Slope LT (%) | N/A |

Remove & Replace Curb Ramp With Two New Directional Ramps or Equivalent.

R204.3, R304.2.2, STD 1115
