# Access Compliance Report Public Rights-of-Way (Curb Ramps)

Main Street: CHRISTY\_LN Cross Street: ANGLER\_LN Location: NE

ADA ID: RPRK211209113612 Ramp Type: Type 1 - Perpendicular Diagonal Initial Pass/Fail: Pass Overall Compliance: No Severity Score: 10

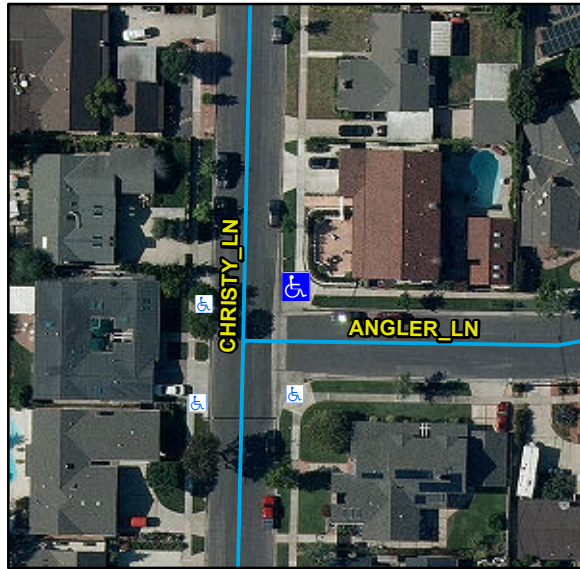
| Compliance | Description | Data | Compliance | Description | Data |
|---|---|---|---|---|---|
| Yes | Landing Cross Slope (%) | 1.9 | No | DWS Provided | No |
| Yes | Overall Surface Condition: Acceptable | | No | Perp Joint Present | No |

Remove & Replace Curb Ramp With Two New Directional Ramps or Equivalent.

R204.3, R305, STD 1115
