# Access Compliance Report Public Rights-of-Way (Curb Ramps)

| Main Street: ANGLER_LN | | Cross Street: BELLWOOD_RD | | Location: | NW |
| ADA ID: RPRK211209114027 | Ramp Type: Type 1 - Perpendicular Diagonal Initial Pass/Fail: Pass | | Overall Compliance: No | Severity Score: | 10 |

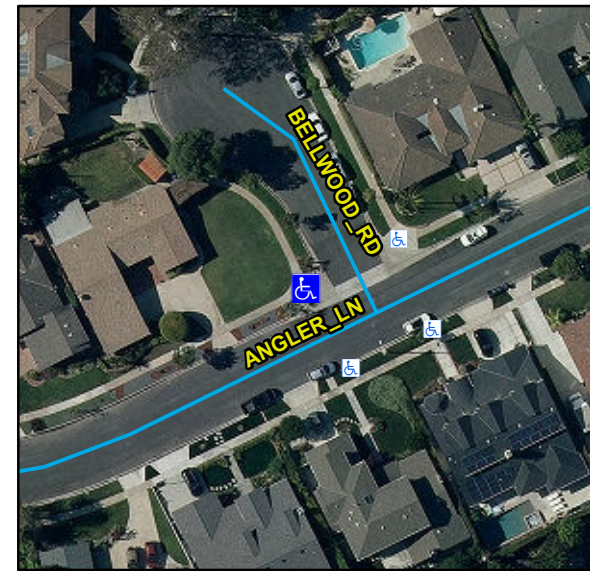
| Compliance | Description | Data | Compliance | Description | Data |
|---|---|---|---|---|---|
| <b>Yes</b> | Landing Cross Slope (%) | <b>1.4</b> | <b>No</b> | DWS Provided | <b>No</b> |

Possible Solutions:  
**Remove & Replace Curb Ramp With Two New Directional Ramps or Equivalent.**

OC Std/PROW:  
**R204.3, R305, STD 1115**

Total Cost: \$ **6160**

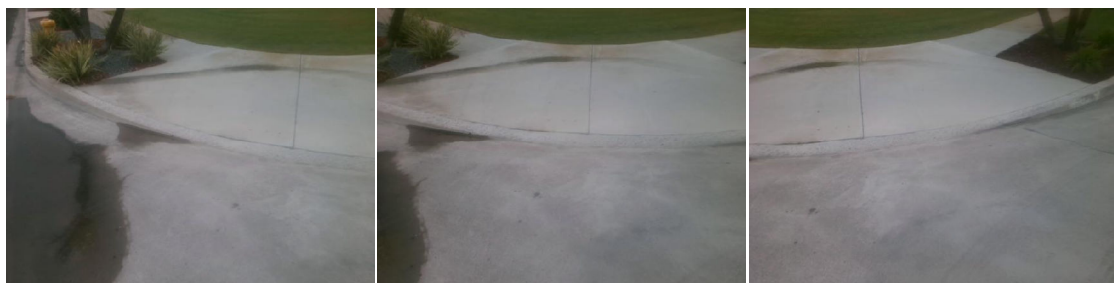
| Compliance | Description | Data | Compliance | Description | Data |
|---|---|---|---|---|---|
| <b>N/A</b> | Ramp Length (in) | <b>82</b> | <b>N/A</b> | Flare Type LT | |
| <b>Yes</b> | Ramp Width (in) | <b>48</b> | | | <b>Sloped</b> |
| <b>Yes</b> | Ramp Run Slope (%) | <b>5.9</b> | <b>N/A</b> | Flare Slope LT (%) | <b>0.6</b> |
| <b>Yes</b> | Ramp Cross Slope (%) | <b>1.2</b> | <b>N/A</b> | Flare Traversable LT | <b>No</b> |
| <b>Yes</b> | Landing Width (in) | <b>48</b> | <b>N/A</b> | Flare Slope RT (%) | <b>7.3</b> |
