# Access Compliance Report Public Rights-of-Way (Curb Ramps)

Main Street: BELLWOOD\_RD Cross Street: ANGLER\_LN Location: NE

ADA ID: RPRK211209114358 Ramp Type: Type 1 - Perpendicular Diagonal Initial Pass/Fail: Pass Overall Compliance: No Severity Score: 10

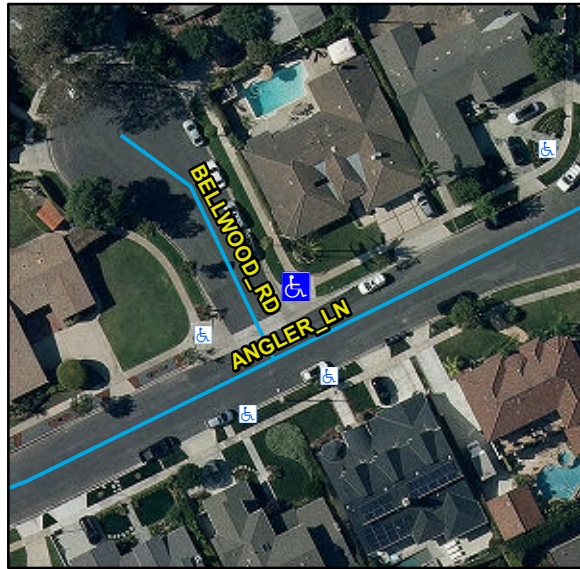
| Compliance | Description | Data | Compliance | Description | Data |
|---|---|---|---|---|---|
| Yes | Landing Cross Slope (%) | 2.2 | No | DWS Provided | No |
| No | Gutter Cross Slope (%) | 4.1 | | | |

**Remove & Replace Curb Ramp With Two New Directional Ramps or Equivalent. Remove & Replace Gutter.**

**R204.3, R304.2.1, R305, R304.5.3, STD 1115**
