# Access Compliance Report Public Rights-of-Way (Curb Ramps)

Main Street: BALLANTINE\_DR Cross Street: BLUME\_DR Location: SW

ADA ID: RPRK211209114942 Ramp Type: Type 1 - Perpendicular Diagonal Initial Pass/Fail: Pass Overall Compliance: No Severity Score: 15

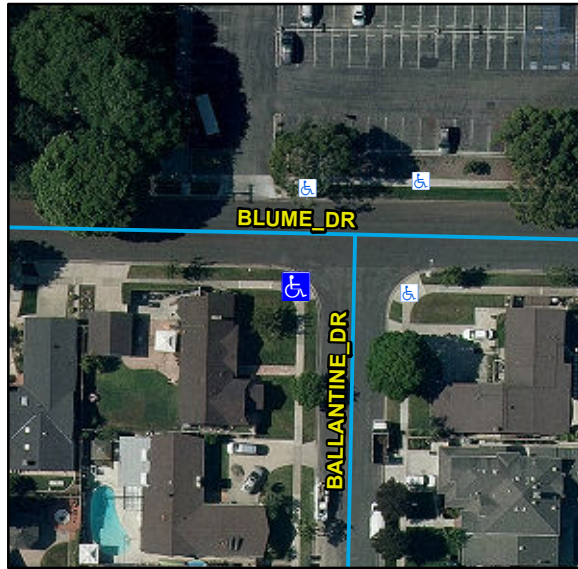
| Compliance | Description | Data | Compliance | Description | Data |
|---|---|---|---|---|---|
| Yes | Landing Cross Slope (%) | 2 | No | DWS Provided | No |
| No | Gutter Run Slope (%) | 7 | | Road Cross Slope (%) | 8.8 |

Remove & Replace Curb Ramp With Two New Directional Ramps or Equivalent. Remove & Replace Gutter.

R204.3, R305, R304.5.4, STD 1115
