# Access Compliance Report Public Rights-of-Way (Curb Ramps)

Main Street: OAK\_WAY\_DR Cross Street: BLUME\_DR Location: SW

ADA ID: RPRK211209115605 Ramp Type: Type 1 - Perpendicular Diagonal Initial Pass/Fail: Pass Overall Compliance: No Severity Score: 19

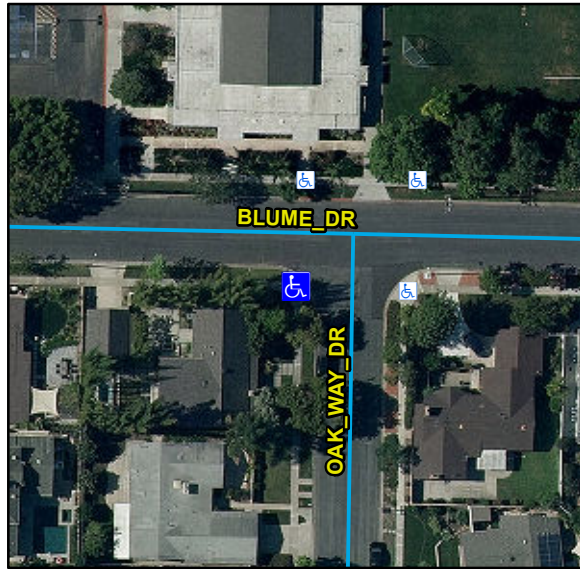
| Compliance | Description | Data | Compliance | Description | Data |
|---|---|---|---|---|---|
| Yes | Landing Cross Slope (%) | 0.6 | No | DWS Provided | No |
| No | Gutter Run Slope (%) | 5.7 | | Road Cross Slope (%) | 8.5 |
| No | Gutter Cross Slope (%) | 2.9 | | | |

Remove & Replace Curb Ramp With Two New Directional Ramps or Equivalent. Remove & Replace Gutter.
