# Access Compliance Report Public Rights-of-Way (Curb Ramps)

Main Street: BLUME\_DR Cross Street: OAK\_WAY\_DR Location: SE

ADA ID: RPRK211209115852 Ramp Type: Type 1 - Perpendicular Diagonal Initial Pass/Fail: Pass Overall Compliance: No Severity Score: 12

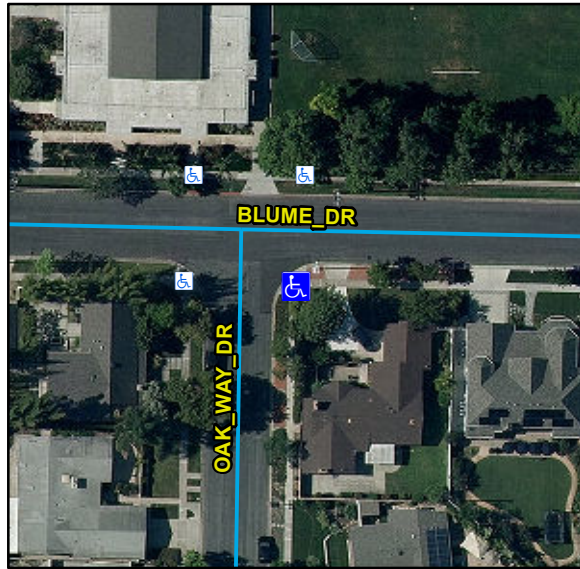
| Compliance | Description | Data | Compliance | Description | Data |
|---|---|---|---|---|---|
| No | Landing Cross Slope (%) | 4.3 | No | DWS Provided | No |

Remove & Replace Curb Ramp With Two New Directional Ramps or Equivalent.

R204.3, R304.5.3, R305, STD 1115
