# Access Compliance Report Public Rights-of-Way (Curb Ramps)

Main Street: MAINWAY\_DR Cross Street: CHIANTI\_DR Location: SE

ADA ID: RPRK211209120841 Ramp Type: Type 1 - Perpendicular Diagonal Initial Pass/Fail: Pass Overall Compliance: No Severity Score: 10

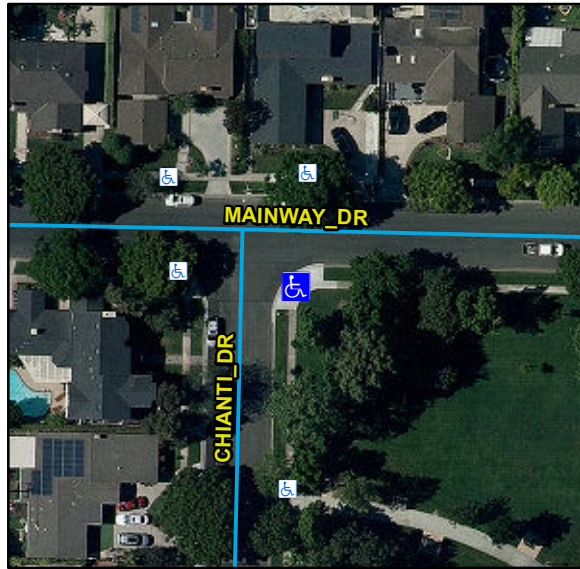
| Compliance | Description | Data | Compliance | Description | Data |
|---|---|---|---|---|---|
| No | Ramp Cross Slope (%) | 2.6 | N/A | Flare Traversable LT | Yes |
| No | Gutter Run Slope (%) | 5.5 | | Road Cross Slope (%) | 8.8 |
| No | Gutter Cross Slope (%) | 2.3 | | | |

Remove & Replace Curb Ramp With Two New Directional Ramps or Equivalent. Remove & Replace Gutter.
