# Access Compliance Report Public Rights-of-Way (Curb Ramps)

Main Street: CHIANTI\_DR Cross Street: MAINWAY\_DR Location: SW

ADA ID: RPRK211209121140 Ramp Type: Type 1 - Perpendicular Diagonal Initial Pass/Fail: Pass Overall Compliance: No Severity Score: 14

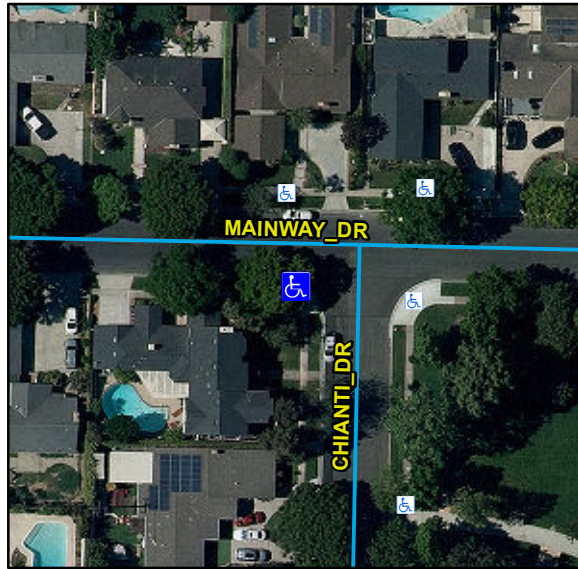
| Compliance | Description | Data | Compliance | Description | Data |
|---|---|---|---|---|---|
| Yes | Landing Cross Slope (%) | 0.7 | No | DWS Provided | No |
| No | Gutter Cross Slope (%) | 2.2 | | | |

Remove & Replace Curb Ramp With Two New Directional Ramps or Equivalent. Remove & Replace Gutter.

R204.3, R304.2.1, R305, R304.5.3, STD 1115
