# Access Compliance Report Public Rights-of-Way (Curb Ramps)

Main Street: FOSTER\_RD Cross Street: MAINWAY\_DR Location: NE

ADA ID: RPRK211209121458 Ramp Type: Type 1 - Perpendicular Diagonal Initial Pass/Fail: Fail Overall Compliance: No Severity Score: 2

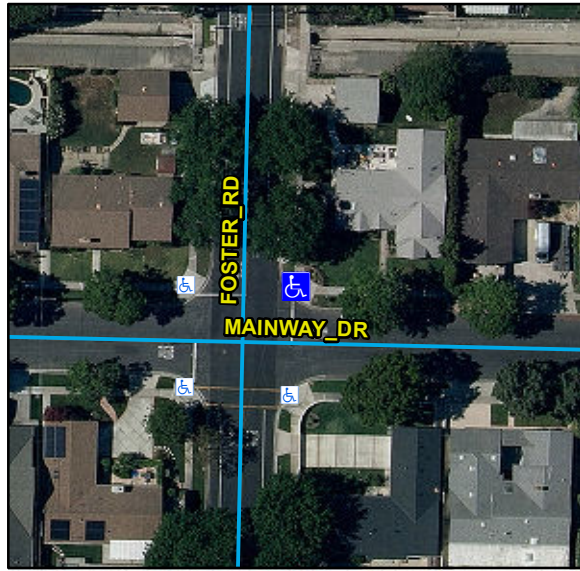
| Compliance | Description | Data | Compliance | Description | Data |
|---|---|---|---|---|---|
| No | Ramp Cross Slope (%) | 2.1 | N/A | Flare Traversable LT | N/A |

**Remove & Replace Curb Ramp With Two New Directional Ramps or Equivalent.**

**R204.3, R304.5.3, STD 1115**
