# Access Compliance Report Public Rights-of-Way (Curb Ramps)

Main Street: MAINWAY\_DR Cross Street: FOSTER\_RD Location: NW

ADA ID: RPRK211209121857 Ramp Type: Type 1 - Perpendicular Diagonal Initial Pass/Fail: Fail Overall Compliance: No Severity Score: 2

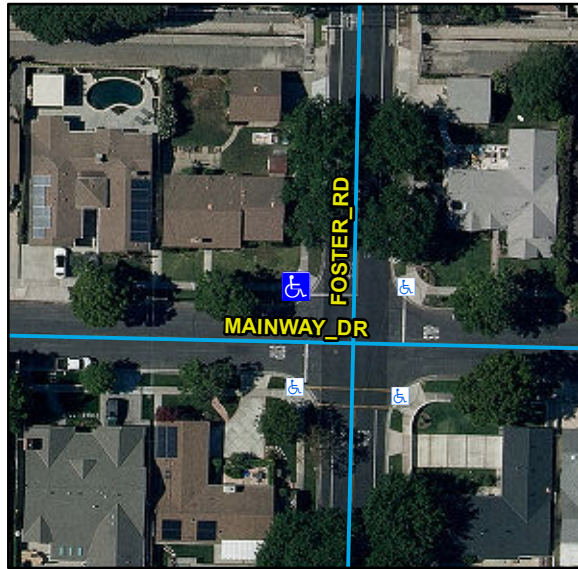
| Compliance | Description | Data | Compliance | Description | Data |
|---|---|---|---|---|---|
| No | Ramp Cross Slope (%) | 3.4 | N/A | Flare Traversable LT | N/A |

Remove & Replace Curb Ramp With Two New Directional Ramps or Equivalent.

R204.3, R304.5.3, STD 1115
