# Access Compliance Report Public Rights-of-Way (Curb Ramps)

Main Street: FOSTER\_RD Cross Street: MAINWAY\_DR Location: SW

ADA ID: RPRK211209122102 Ramp Type: Type 1 - Perpendicular Diagonal Initial Pass/Fail: Pass Overall Compliance: No Severity Score: 16

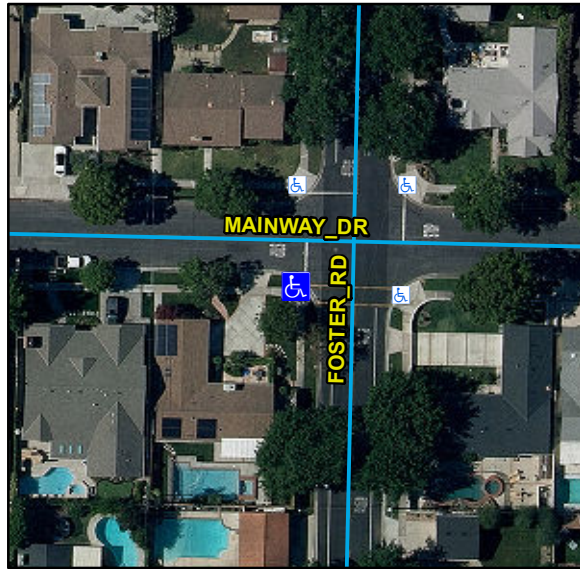
| Compliance | Description | Data | Compliance | Description | Data |
|---|---|---|---|---|---|
| Yes | Ramp Run Slope (%) | 6 | N/A | Flare Slope LT (%) | 5.6 |
| No | Landing Run Slope (%) | 2.4 | N/A | Flare Traversable RT | No |
| No | Landing Cross Slope (%) | 2.5 | No | DWS Provided | No |
| No | Gutter Ponding | Yes | No | Curb Slope | 6.3 |
| No | Gutter Run Slope (%) | 7 | | Road Cross Slope (%) | 6.5 |

Remove & Replace Curb Ramp With Two New Directional Ramps or Equivalent. Restripe Crosswalk. Remove & Replace Gutter.
