# Access Compliance Report Public Rights-of-Way (Curb Ramps)

Main Street: MAINWAY\_DR Cross Street: FOSTER\_RD Location: SE

ADA ID: RPRK211209122412 Ramp Type: Type 1 - Perpendicular Diagonal Initial Pass/Fail: Fail Overall Compliance: No Severity Score: 2

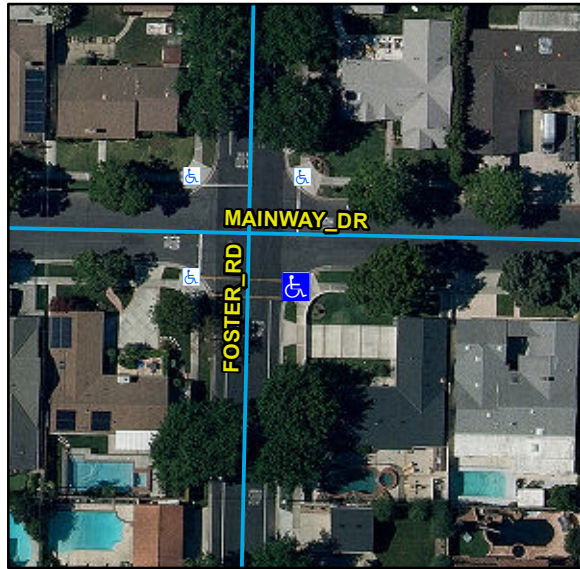
| Compliance | Description | Data | Compliance | Description | Data |
|---|---|---|---|---|---|
| No | Ramp Cross Slope (%) | 2.3 | N/A | Flare Traversable LT | N/A |

Remove & Replace Curb Ramp With Two New Directional Ramps or Equivalent.

R204.3, R304.5.3, STD 1115
