# Access Compliance Report Public Rights-of-Way (Curb Ramps)

Main Street: FOSTER\_RD Cross Street: TUCKER\_LN Location: NE

ADA ID: RPRK211209122645 Ramp Type: Type 1 - Perpendicular Diagonal Initial Pass/Fail: Pass Overall Compliance: No Severity Score: 10

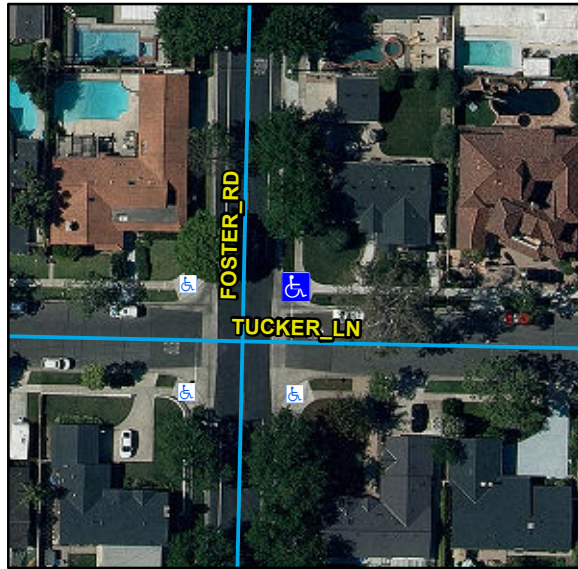
| Compliance | Description | Data | Compliance | Description | Data |
|---|---|---|---|---|---|
| Yes | Landing Cross Slope (%) | 0.5 | No | DWS Provided | No |

Remove & Replace Curb Ramp With Two New Directional Ramps or Equivalent.
