# Access Compliance Report Public Rights-of-Way (Curb Ramps)

Main Street: FOSTER\_RD Cross Street: TUCKER\_LN Location: SW

ADA ID: RPRK211209123149 Ramp Type: Type 1 - Perpendicular Diagonal Initial Pass/Fail: Pass Overall Compliance: No Severity Score: 10

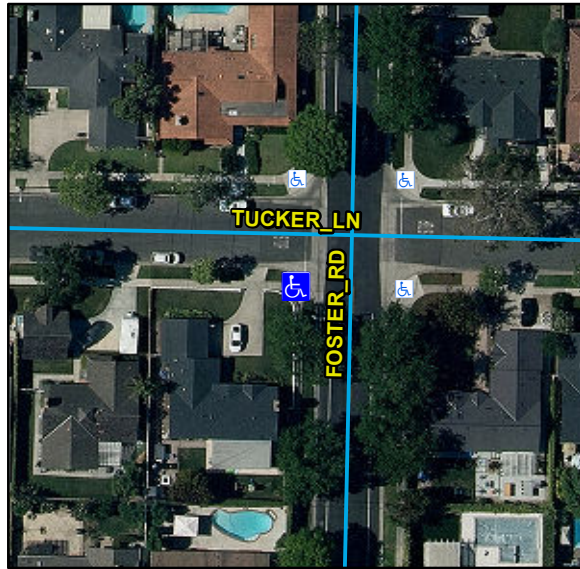
| Compliance | Description | Data | Compliance | Description | Data |
|---|---|---|---|---|---|
| Yes | Landing Cross Slope (%) | 1.4 | No | DWS Provided | No |
| N/A | Landing Movement Obstructed? | Yes | N/A | DWS Contrast | N/A |
| | Landing Movement Type | Fence | N/A | DWS Length (in) | N/A |
| No | Gutter Cross Slope (%) | 2.3 | | | |

**Remove & Replace Curb Ramp With Two New Directional Ramps or Equivalent. Remove & Replace Gutter.**

**R204.3, R304.2.1, R305, R304.5.3, STD 1115**
