# Access Compliance Report Public Rights-of-Way (Curb Ramps)

Main Street: TUCKER\_LN Cross Street: FOSTER\_RD Location: NW

ADA ID: RPRK211209123441 Ramp Type: Type 1 - Perpendicular Diagonal Initial Pass/Fail: Pass Overall Compliance: No Severity Score: 10

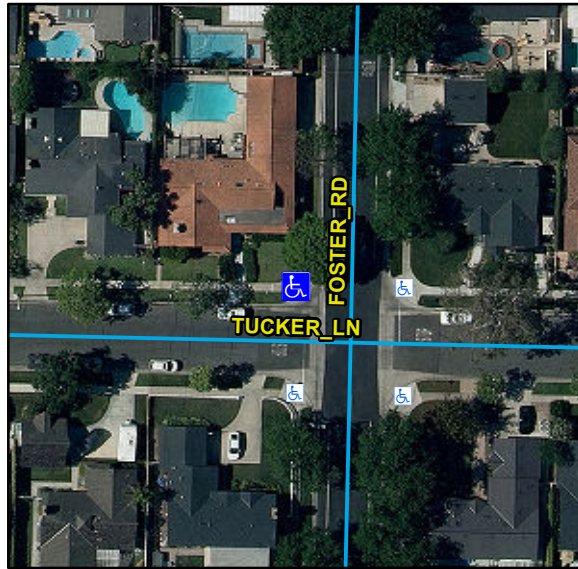
| Compliance | Description | Data | Compliance | Description | Data |
|---|---|---|---|---|---|
| Yes | Landing Cross Slope (%) | 1.8 | No | DWS Provided | No |
| No | Gutter Cross Slope (%) | 2.8 | | | |

Remove & Replace Curb Ramp With Two New Directional Ramps or Equivalent. Remove & Replace Gutter.
