# Access Compliance Report Public Rights-of-Way (Curb Ramps)

| Main Street: MONTECITO_RD | | Cross Street: WOODSTOCK_RD | | Location: | SW |
| ADA ID: RPRK211209125627 | Ramp Type: Type 4 - Parallel | Initial Pass/Fail: Fail | Overall Compliance: No | Severity Score: | 15 |

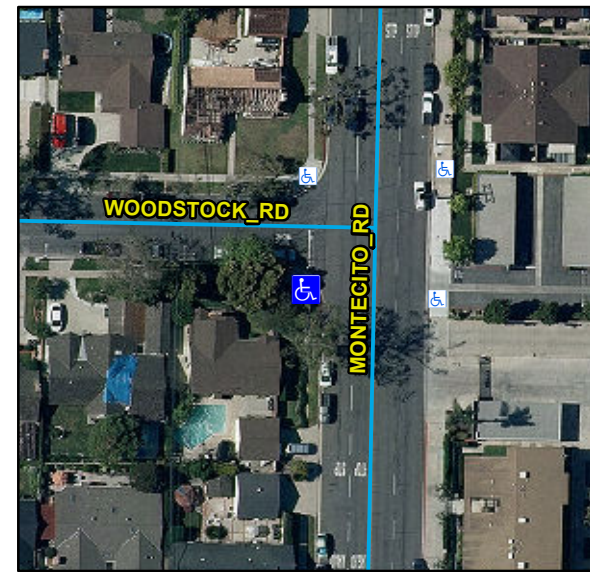
| Compliance | Description | Data | Compliance | Description | Data |
|---|---|---|---|---|---|
| No | Ramp Cross Slope LT (%) | 3.4 | No | Ramp Cross Slope RT (%) | 6.7 |

**Remove & Replace Curb Ramp With Two New Directional Ramps or Equivalent.**

**R204.3, R304.5.3, STD 1115**
