# Access Compliance Report Public Rights-of-Way (Curb Ramps)

Main Street: WOODSTOCK\_RD Cross Street: MONTECITO\_RD Location: NW

ADA ID: RPRK211209125939 Ramp Type: Type 1 - Perpendicular Diagonal Initial Pass/Fail: Fail Overall Compliance: No Severity Score: 2

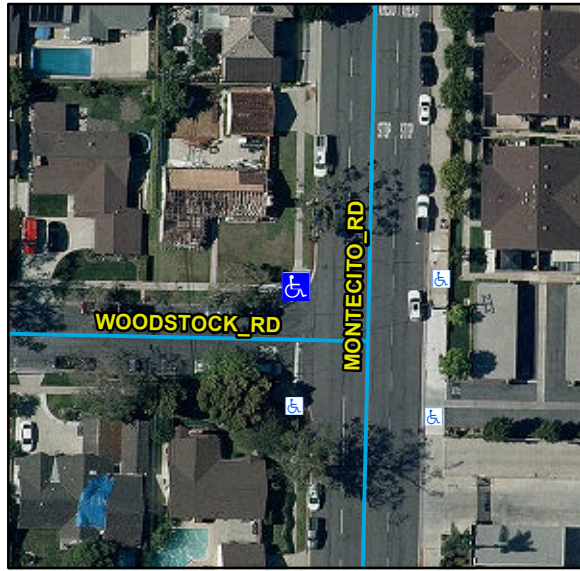
| Compliance | Description | Data | Compliance | Description | Data |
|---|---|---|---|---|---|
| No | Ramp Cross Slope (%) | 2.2 | N/A | Flare Traversable LT | N/A |

**Remove & Replace Curb Ramp With Two New Directional Ramps or Equivalent.**

**R304.2.2, R204.3, R304.5.3, STD 1115**
