# Access Compliance Report Public Rights-of-Way (Curb Ramps)

Main Street: MONTECITO\_RD Cross Street: OAK\_GROVE\_RD Location: SW

ADA ID: RPRK211209130204 Ramp Type: Type 1 - Perpendicular Diagonal Initial Pass/Fail: Pass Overall Compliance: No Severity Score: 5

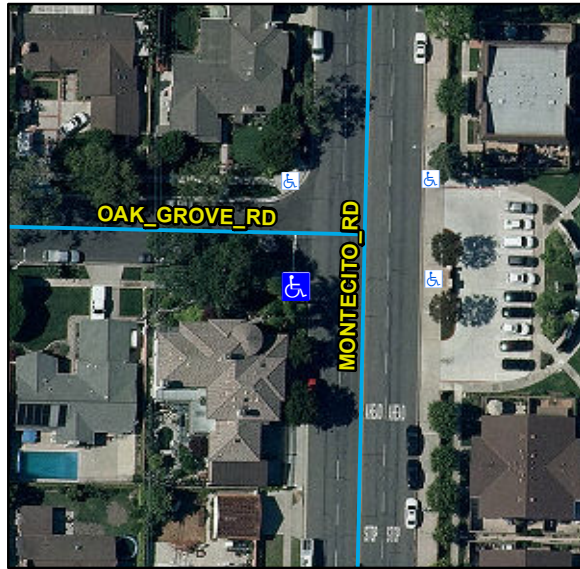
R304.5.4, R304.5.3, STD 1115

| Compliance | Description | Data | Compliance | Description | Data |
|---|---|---|---|---|---|
| No | Gutter Run Slope (%) | 6.6 | | Road Cross Slope (%) | 7.4 |
| No | Gutter Cross Slope (%) | 2.7 | | | |

Remove & Replace Gutter.
