# Access Compliance Report Public Rights-of-Way (Curb Ramps)

Main Street: OAK GROVE RD Cross Street: MONTECITO RD Location: NW

ADA ID: RPRK211209130549 Ramp Type: Type 1 - Perpendicular Diagonal Initial Pass/Fail: Pass Overall Compliance: No Severity Score: 5

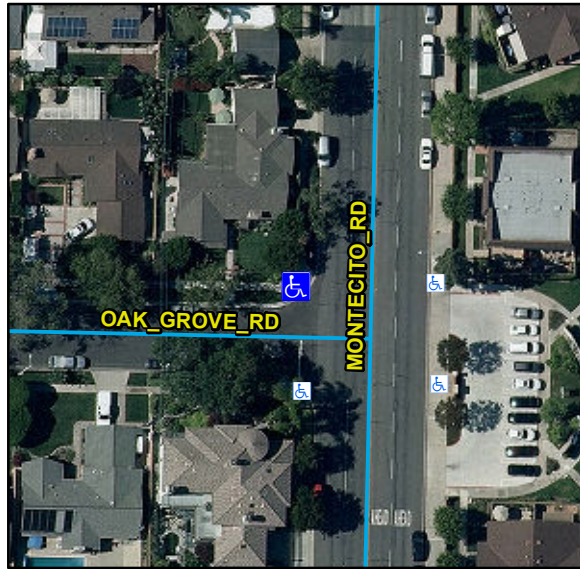
| Compliance | Description | Data | Compliance | Description | Data |
|---|---|---|---|---|---|
| No | Gutter Run Slope (%) | 7.6 | | Road Cross Slope (%) | 8.1 |
| No | Gutter Cross Slope (%) | 3.5 | | | |

Possible Solutions:

Remove & Replace Gutter.

R304.5.4, R304.5.3, STD 1115
