# Access Compliance Report Public Rights-of-Way (Curb Ramps)

Main Street: MONTECITO\_RD Cross Street: BRADBURY\_RD Location: SW

ADA ID: RPRK211209130907 Ramp Type: Type 1 - Perpendicular Diagonal Initial Pass/Fail: Fail Overall Compliance: No Severity Score: 2

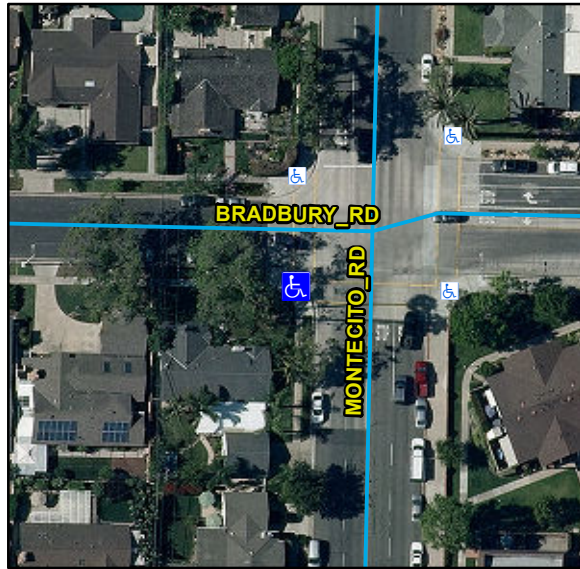
| Compliance | Description | Data | Compliance | Description | Data |
|---|---|---|---|---|---|
| No | Ramp Cross Slope (%) | 2.9 | N/A | Flare Traversable LT | N/A |

Remove & Replace Curb Ramp With Two New Directional Ramps or Equivalent.

R304.5.3, STD 1115
