# Access Compliance Report Public Rights-of-Way (Curb Ramps)

Main Street: BRADBURY\_RD Cross Street: MONTECITO\_RD Location: SE

ADA ID: RPRK211209131123 Ramp Type: Type 1 - Perpendicular Diagonal Initial Pass/Fail: Fail Overall Compliance: No Severity Score: 2

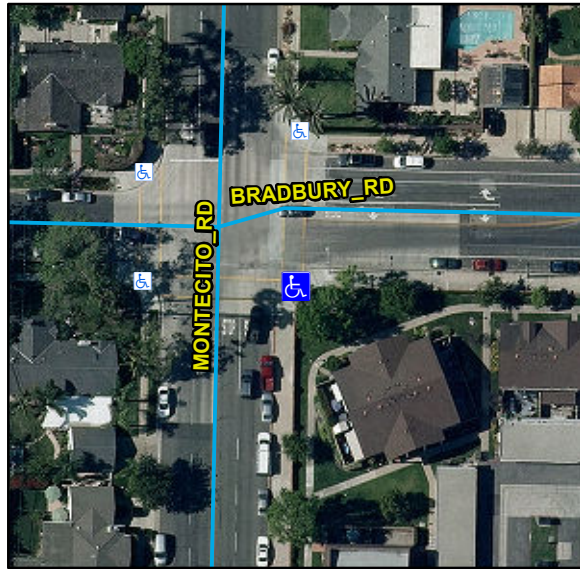
| Compliance | Description | Data | Compliance | Description | Data |
|---|---|---|---|---|---|
| No | Ramp Cross Slope (%) | 2.1 | N/A | Flare Traversable LT | N/A |

**Remove & Replace Curb Ramp With Two New Directional Ramps or Equivalent.**

**R304.5.3, STD 1115**
