# Access Compliance Report Public Rights-of-Way (Curb Ramps)

Main Street: MONTECITO\_RD Cross Street: BRADBURY\_RD Location: NE

ADA ID: RPRK211209131336 Ramp Type: Type 1 - Perpendicular Diagonal Initial Pass/Fail: Pass Overall Compliance: No Severity Score: 4

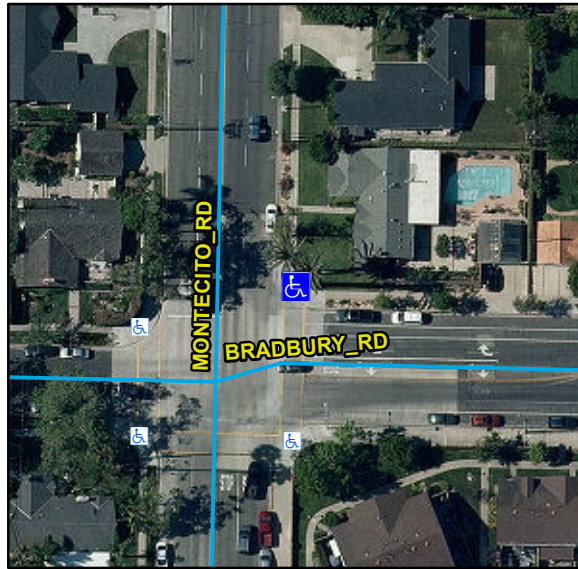
| Compliance | Description | Data | Compliance | Description | Data |
|---|---|---|---|---|---|
| Yes | Gutter Ponding | No | No | Curb Slope | 6.6 |
| No | Gutter Cross Slope (%) | 2.2 | | | |

Remove & Replace Curb Ramp With Two New Directional Ramps or Equivalent. Remove & Replace Gutter.
