# Access Compliance Report Public Rights-of-Way (Curb Ramps)

Main Street: BRADBURY\_RD Cross Street: MONTECITO\_RD Location: NW

ADA ID: RPRK211209131709 Ramp Type: Type 1 - Perpendicular Diagonal Initial Pass/Fail: Fail Overall Compliance: No Severity Score: 2

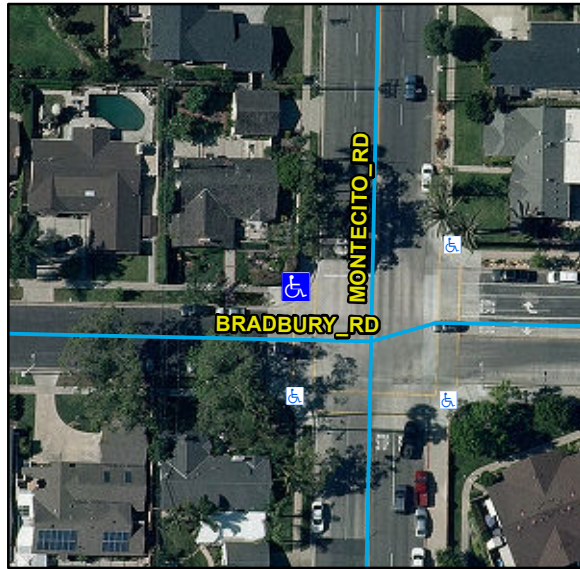
| Compliance | Description | Data | Compliance | Description | Data |
|---|---|---|---|---|---|
| No | Ramp Cross Slope (%) | 2.1 | N/A | Flare Traversable LT | N/A |

Remove & Replace Curb Ramp With Two New Directional Ramps or Equivalent.

R304.2.2, R304.5.3, STD 1115
