# Access Compliance Report Public Rights-of-Way (Curb Ramps)

| Main Street: MONTECITO_RD | | Cross Street: WENDY_WAY | | Location: | NE |
| ADA ID: RPRK211209132132 | Ramp Type: Type 4 - Parallel | Initial Pass/Fail: Fail | Overall Compliance: No | Severity Score: | 16 |

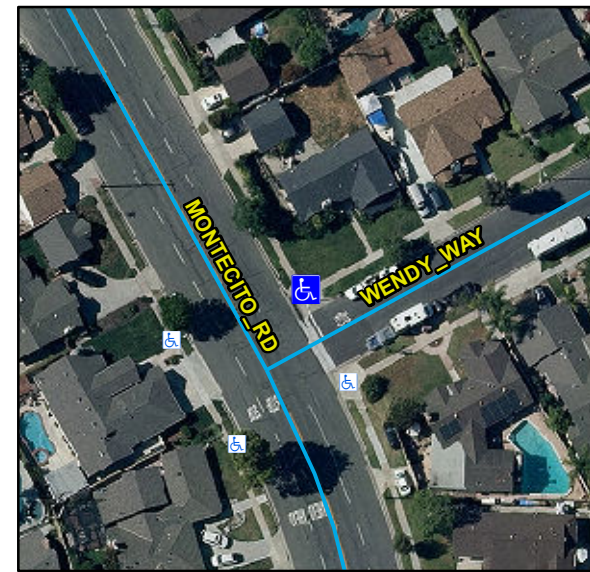
| Compliance | Description | Data | Compliance | Description | Data |
|---|---|---|---|---|---|
| Yes | Ramp Run Slope LT (%) | 2.7 | No | Ramp Run Slope RT (%) | 8.6 |
| No | Ramp Cross Slope LT (%) | 2.1 | No | Ramp Cross Slope RT (%) | 4.4 |

Possible Solutions:

**Remove & Replace Curb Ramp With Two New Directional Ramps or Equivalent.**

**R204.3, R304.5.3, R304.3.2, STD 1115**

Total Cost: \$ 4000

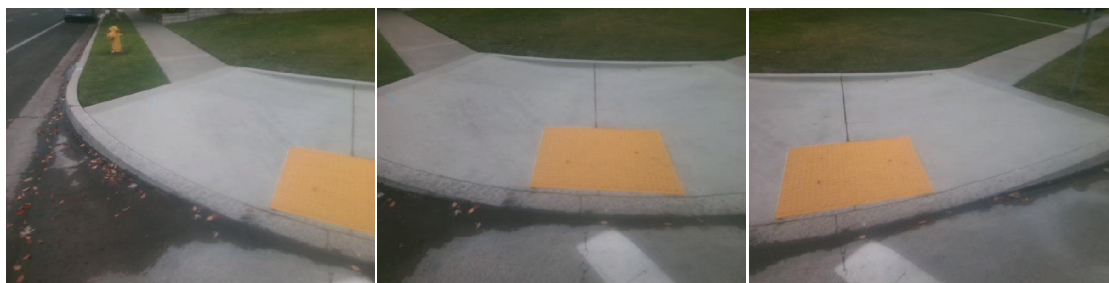
| Compliance | Description | Data | Compliance | Description | Data |
|---|---|---|---|---|---|
| N/A | Ramp Length LT (in) | 108 | N/A | Ramp Length RT (in) | 109 |
| Yes | Ramp Width LT (in) | 119 | Yes | Ramp Width RT (in) | 118 |
| | Crossing 1 Slope (%) | 8.9 | | Crossing 2 Slope (%) | 0.7 |
| N/A | Gutter Ponding | N/A | N/A | Curb Slope | 5.9 |
