# Access Compliance Report Public Rights-of-Way (Curb Ramps)

Main Street: WENDY WAY Cross Street: MONTECITO\_RD Location: SE

ADA ID: RPRK211209132401 Ramp Type: Type 4 - Parallel Initial Pass/Fail: Fail Overall Compliance: No Severity Score: 15

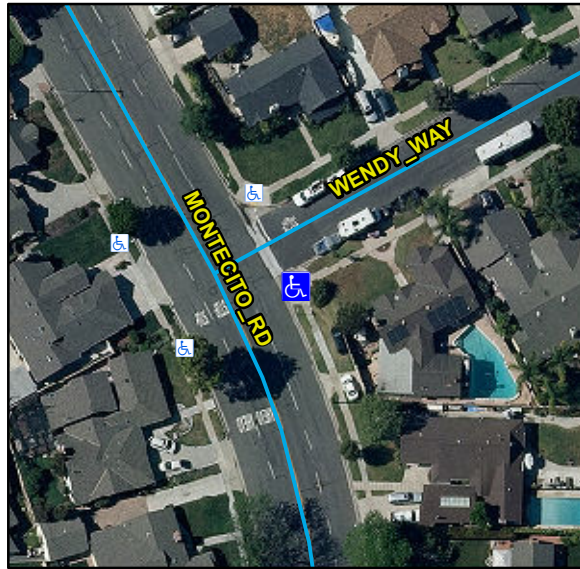
| Compliance | Description | Data | Compliance | Description | Data |
|---|---|---|---|---|---|
| Yes | Ramp Cross Slope LT (%) | 1.4 | No | Ramp Cross Slope RT (%) | 5.3 |

Remove & Replace Curb Ramp With Two New Directional Ramps or Equivalent.

R304.5.3, STD 1115
