# Access Compliance Report Public Rights-of-Way (Curb Ramps)

Main Street: DAVENPORT\_RD Cross Street: BRADBURY\_RD Location: NE

ADA ID: RPRK211209133758 Ramp Type: Type 4 - Parallel Initial Pass/Fail: Fail Overall Compliance: No Severity Score: 2

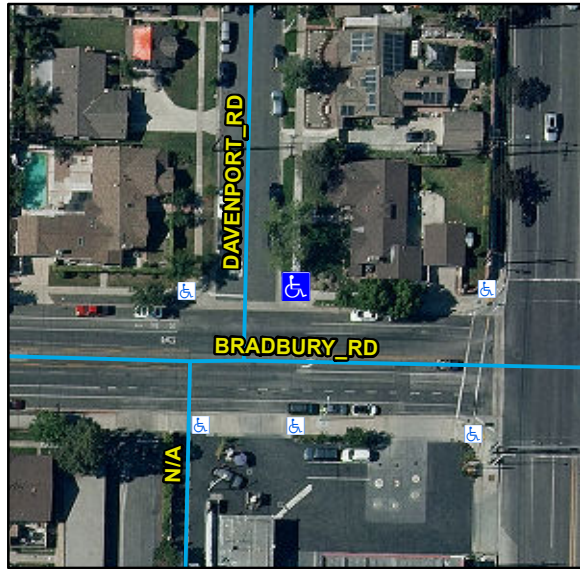
| Compliance | Description | Data | Compliance | Description | Data |
|---|---|---|---|---|---|
| No | Ramp Cross Slope LT (%) | 2.8 | No | Ramp Cross Slope RT (%) | 3.2 |

Remove & Replace Curb Ramp With Two New Directional Ramps or Equivalent.

R204.3, R304.5.3, STD 1115
