# Access Compliance Report Public Rights-of-Way (Curb Ramps)

Main Street: BRADBURY\_RD Cross Street: DAVENPORT\_RD Location: NW

ADA ID: RPRK211209134058 Ramp Type: Type 4 - Parallel Initial Pass/Fail: Fail Overall Compliance: No Severity Score: 45

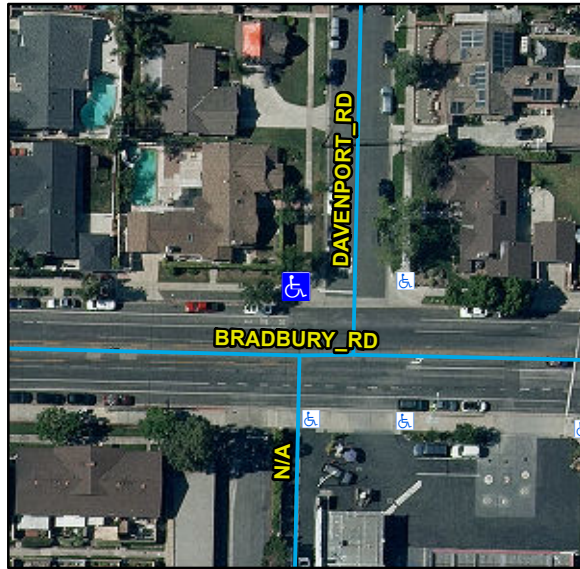
| Compliance | Description | Data | Compliance | Description | Data |
|---|---|---|---|---|---|
| Yes | Ramp Run Slope LT (%) | 2.7 | No | Ramp Run Slope RT (%) | 11.7 |
| No | Ramp Cross Slope LT (%) | 5.7 | No | Ramp Cross Slope RT (%) | 8.8 |

Remove & Replace Curb Ramp With Two New Directional Ramps or Equivalent.
