# Access Compliance Report Public Rights-of-Way (Curb Ramps)

Main Street: WEATHERBY\_RD Cross Street: BRADBURY\_RD Location: NE

ADA ID: RPRK211209134322 Ramp Type: Type 1 - Perpendicular Diagonal Initial Pass/Fail: Pass Overall Compliance: No Severity Score: 0

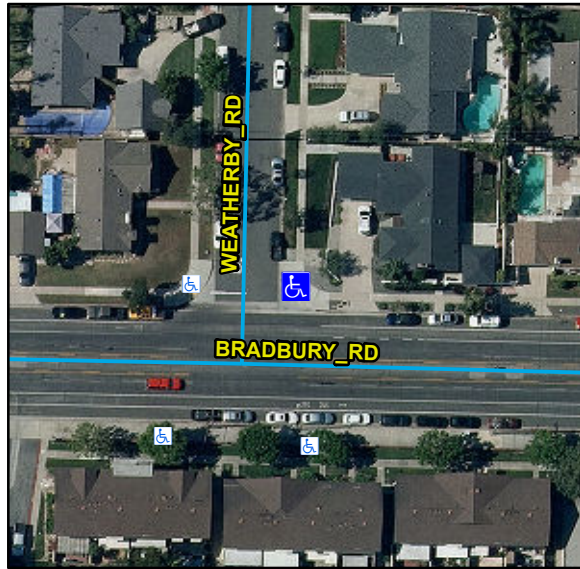
| Compliance | Description | Data | Compliance | Description | Data |
|---|---|---|---|---|---|
| No | Landing Cross Slope (%) | 3.1 | Yes | DWS Provided | Yes |

Possible Solutions:

Remove & Replace Landing.

R304.5.3, STD 1115
