# Access Compliance Report Public Rights-of-Way (Curb Ramps)

Main Street: BRADBURY\_RD Cross Street: WEATHERBY\_RD Location: NW

ADA ID: RPRK211209134713 Ramp Type: Type 1 - Perpendicular Diagonal Initial Pass/Fail: Pass Overall Compliance: No Severity Score: 5

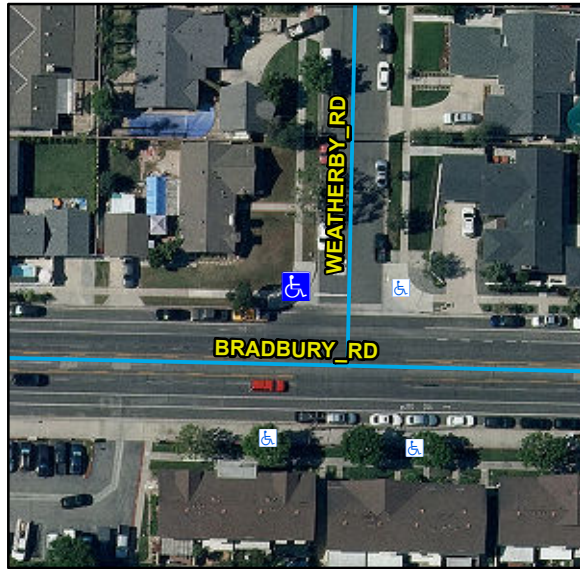
| Compliance | Description | Data | Compliance | Description | Data |
|---|---|---|---|---|---|
| No | Gutter Ponding | Yes | No | Curb Slope | 6.3 |
| No | Gutter Run Slope (%) | 6 | | Road Cross Slope (%) | 0.2 |
| No | Gutter Cross Slope (%) | 3.7 | | | |

Remove & Replace Curb Slope. Remove & Replace Gutter.
