# Access Compliance Report Public Rights-of-Way (Curb Ramps)

Main Street: WALLINGSFORD\_RD Cross Street: BRADBURY\_RD Location: NE

ADA ID: RPRK211209135000 Ramp Type: Type 1 - Perpendicular Diagonal Initial Pass/Fail: Pass Overall Compliance: No Severity Score: 0

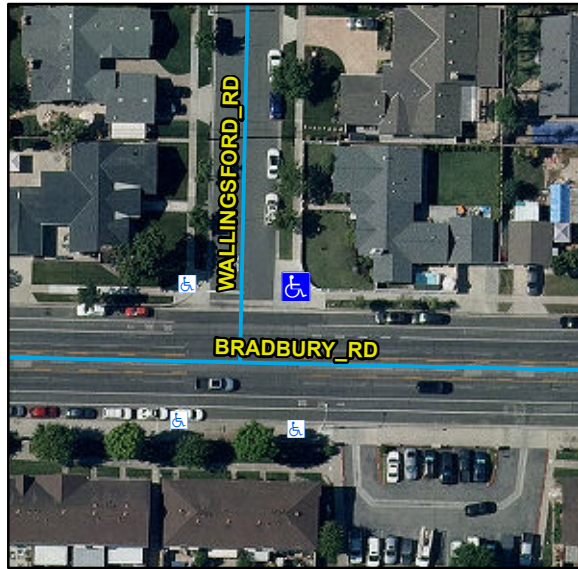
| Compliance | Description | Data | Compliance | Description | Data |
|---|---|---|---|---|---|
| No | Landing Cross Slope (%) | 2.6 | Yes | DWS Provided | Yes |

Remove & Replace Landing.

R304.5.3, STD 1115
