# Access Compliance Report Public Rights-of-Way (Curb Ramps)

Main Street: BRADBURY\_RD Cross Street: WALLINGSFORD\_RD Location: NW

ADA ID: RPRK211209135350 Ramp Type: Type 1 - Perpendicular Diagonal Initial Pass/Fail: Fail Overall Compliance: No Severity Score: 15

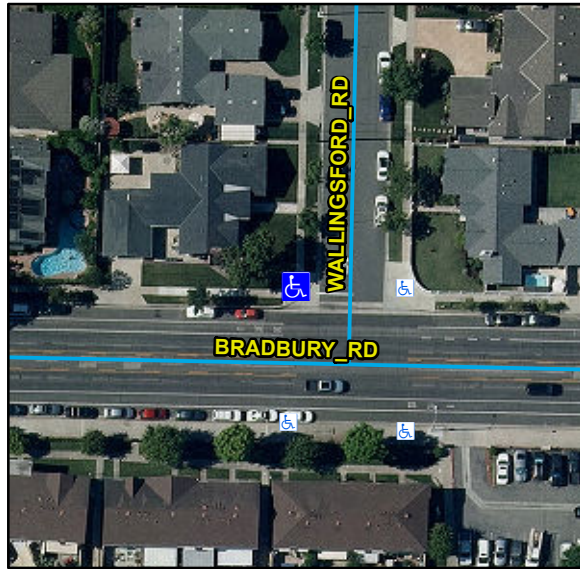
| Compliance | Description | Data | Compliance | Description | Data |
|---|---|---|---|---|---|
| No | Ramp Run Slope (%) | 8.6 | N/A | Flare Slope LT (%) | N/A |

Remove & Replace Curb Ramp With Two New Directional Ramps or Equivalent.

R304.2.2, STD 1115
