# Access Compliance Report Public Rights-of-Way (Curb Ramps)

| Main Street: BRADBURY_RD | | Cross Street: OLD_MILL_RD | | Location: | NW |
| ADA ID: RPRK211209135759 | Ramp Type: Type 4 - Parallel | Initial Pass/Fail: Fail | Overall Compliance: No | Severity Score: | 15 |

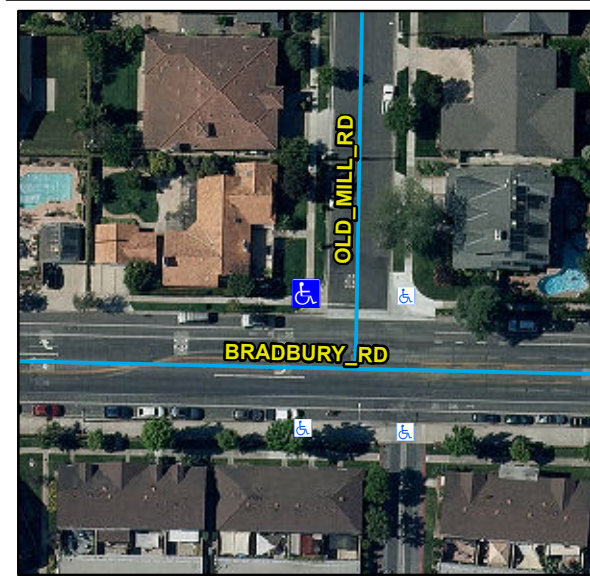
| Compliance | Description | Data | Compliance | Description | Data |
|---|---|---|---|---|---|
| No | Ramp Cross Slope LT (%) | 4 | No | Ramp Cross Slope RT (%) | 5.9 |

**Remove & Replace Curb Ramp With Two New Directional Ramps or Equivalent.**

**R204.3, R304.5.3, STD 1115**
