# Access Compliance Report Public Rights-of-Way (Curb Ramps)

Main Street: INVERNESS\_DR Cross Street: SILVER\_FOX\_RD Location: SE

ADA ID: RPRK211210122828 Ramp Type: Blended Transition 1 Initial Pass/Fail: Fail Overall Compliance: No Severity Score: 30

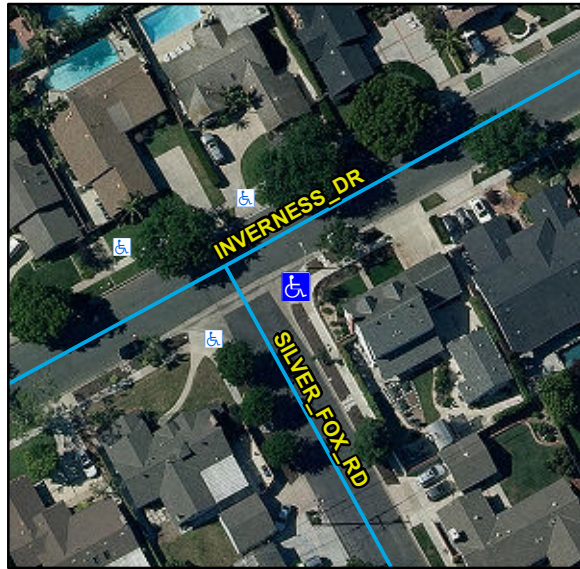
| Compliance | Description | Data | Compliance | Description | Data |
|---|---|---|---|---|---|
| No | Ramp Cross Slope (%) | 10.1 | N/A | Flare Traversable RT | N/A |

Remove & Replace Curb Ramp With Two New Directional Ramps or Equivalent.

R304.5.3, STD 1115
