# Access Compliance Report Public Rights-of-Way (Curb Ramps)

Main Street: FOSTER\_RD Cross Street: INVERNESS\_DR Location: W

ADA ID: RPRK211210124315 Ramp Type: Type 4 - Parallel Initial Pass/Fail: Fail Overall Compliance: No Severity Score: 30

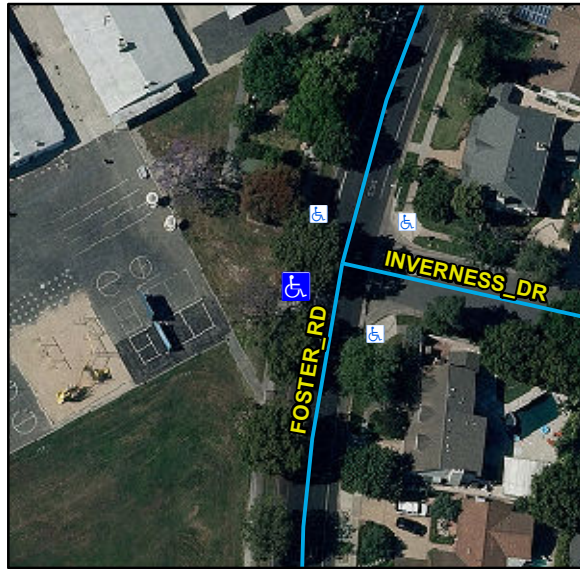
| Compliance | Description | Data | Compliance | Description | Data |
|---|---|---|---|---|---|
| No | Ramp Cross Slope LT (%) | 5.6 | No | Ramp Cross Slope RT (%) | 9.6 |

Remove & Replace Entire Ramp.

R304.5.3, STD 1115
