# Access Compliance Report Public Rights-of-Way (Curb Ramps)

| Main Street: FOSTER_RD | | Cross Street: ACECA_DR | | Location: | W |
| ADA ID: RPRK211210130132 | Ramp Type: Type 4 - Parallel | Initial Pass/Fail: Fail | Overall Compliance: No | Severity Score: | 16 |

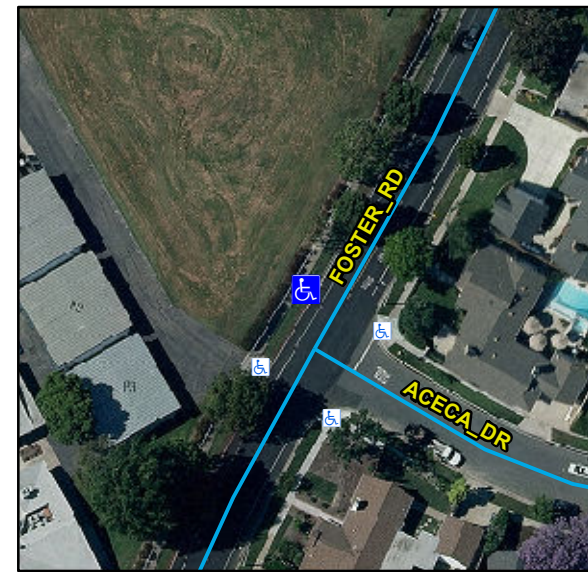
| Compliance | Description | Data | Compliance | Description | Data |
|---|---|---|---|---|---|
| No | Ramp Run Slope LT (%) | 10.2 | No | Ramp Run Slope RT (%) | 10.2 |
| No | Ramp Cross Slope LT (%) | 2.9 | No | Ramp Cross Slope RT (%) | 2.9 |

Possible Solutions:

Remove & Replace Entire Ramp.

R304.3.2, R304.5.3, STD 1115

\$ 2000
