# Access Compliance Report Public Rights-of-Way (Curb Ramps)

| Main Street: MONTECITO_RD | | Cross Street: LORING_DR | | Location: | E |
| ADA ID: RPRK211210134832 | Ramp Type: Type 4 - Parallel | Initial Pass/Fail: Pass | Overall Compliance: No | Severity Score: | 2 |

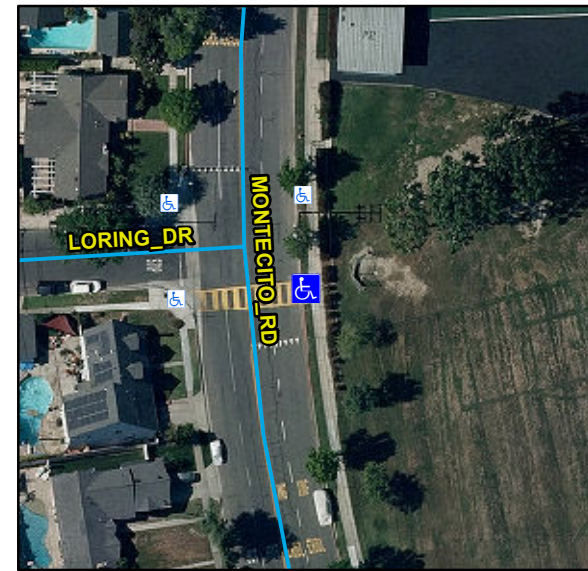
| Compliance | Description | Data | Compliance | Description | Data |
|---|---|---|---|---|---|
| No | Ramp Cross Slope LT (%) | 2.6 | No | Ramp Cross Slope RT (%) | 2.8 |
| No | Landing Run Slope (%) | 3.2 | Yes | DWS Full Width | Yes |
| No | Gutter Cross Slope (%) | 8.8 | Yes | Perpendicular Joint Present | Yes |

**Remove & Replace Entire Ramp. Remove & Replace Gutter.**

**R304.5.3, R304.2.2-Perp, R304.3.2-Para, STD 1115**
