# Access Compliance Report Public Rights-of-Way (Curb Ramps)

Main Street: LORING\_DR Cross Street: MONTECITO\_RD Location: NW

ADA ID: RPRK211210135403 Ramp Type: Blended Transition 1 Initial Pass/Fail: Fail Overall Compliance: No Severity Score: 30

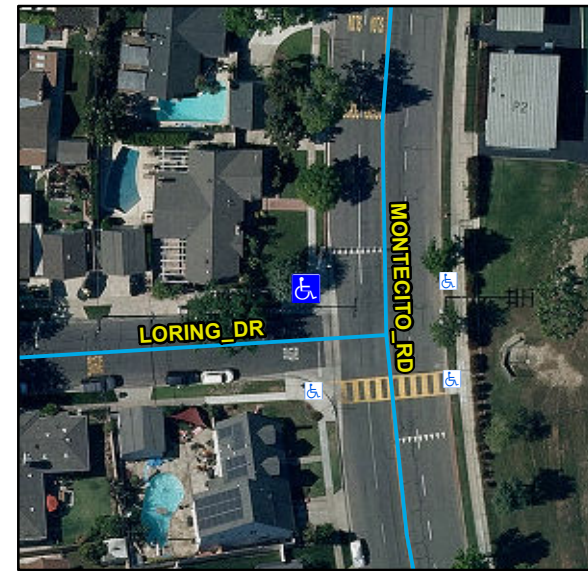
| Compliance | Description | Data | Compliance | Description | Data |
|---|---|---|---|---|---|
| No | Ramp Cross Slope (%) | 9.3 | N/A | Flare Traversable RT | N/A |

Remove & Replace Curb Ramp With Two New Directional Ramps or Equivalent.

R304.5.3, STD 1115
