# Access Compliance Report Public Rights-of-Way (Curb Ramps)

| Main Street: GERTRUDE_DR | | Cross Street: WEMBLEY_RD | | Location: | S |
| ADA ID: RPRK211210152142 | Ramp Type: Type 1 - Perpendicular | Initial Pass/Fail: Fail | Overall Compliance: No | Severity Score: | 15 |

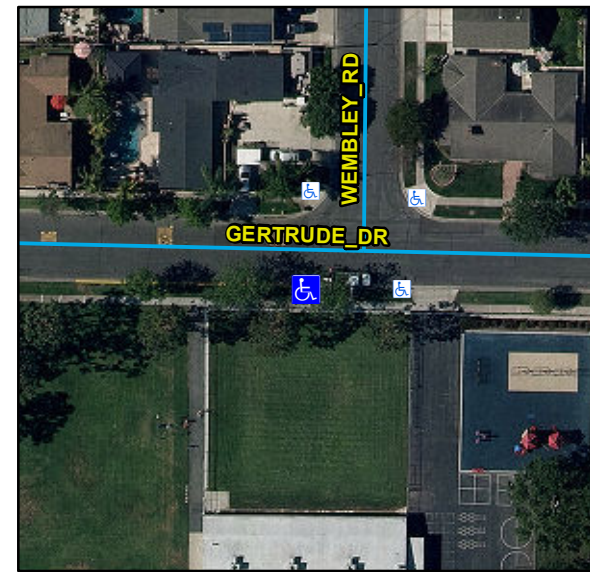
| Compliance | Description | Data | Compliance | Description | Data |
|---|---|---|---|---|---|
| No | Ramp Run Slope (%) | 9.2 | N/A | Flare Slope LT (%) | N/A |

Possible Solutions:

Remove & Replace Entire Ramp.

R304.2.2, STD 1115
