# Access Compliance Report Public Rights-of-Way (Curb Ramps)

Main Street: HARRISBURG\_RD Cross Street: WEATHERBY\_RD Location: SE

ADA ID: RPRK211215114357 Ramp Type: Type 1 - Perpendicular Diagonal Initial Pass/Fail: Pass Overall Compliance: No Severity Score: 6

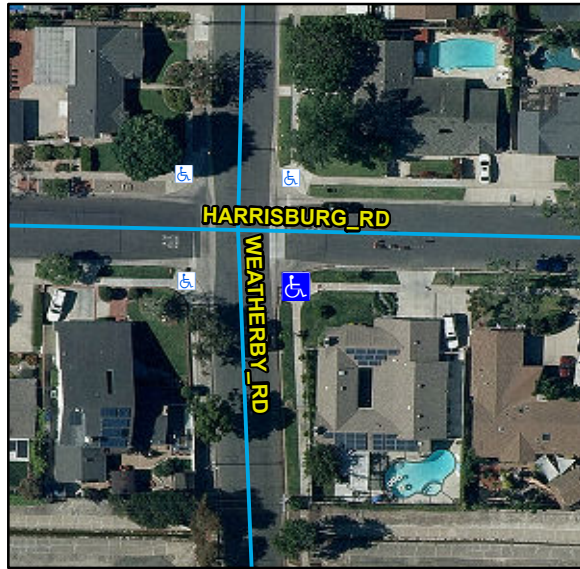
| Compliance | Description | Data | Compliance | Description | Data |
|---|---|---|---|---|---|
| No | Landing Run Slope (%) | 3.1 | N/A | Flare Traversable RT | No |
| No | Gutter Lip Height (in) | 0.25 | | Road Run Slope (%) | 2.3 |
| No | Gutter Run Slope (%) | 6.2 | | Road Cross Slope (%) | 3.4 |
| No | Gutter Cross Slope (%) | 2.3 | | | |

Remove & Replace Landing. Remove & Replace Gutter.
