# Access Compliance Report Public Rights-of-Way (Curb Ramps)

Main Street: WEATHERBY\_RD Cross Street: HARRISBURG\_RD Location: NE

ADA ID: RPRK211215114734 Ramp Type: Type 1 - Perpendicular Diagonal Initial Pass/Fail: Pass Overall Compliance: No Severity Score: 0

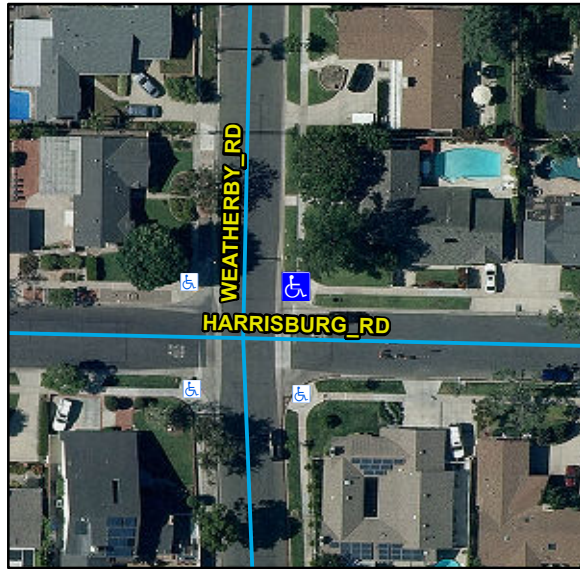
| Compliance | Description | Data | Compliance | Description | Data |
|---|---|---|---|---|---|
| No | Landing Run Slope (%) | 3 | N/A | Flare Traversable RT | No |
| Yes | Gutter Ponding | No | No | Curb Slope | 5.2 |

Remove & Replace Curb Ramp With Two New Directional Ramps or Equivalent.

R304.2.2, R304.2.2-Perp, R304.3.2-Para, STD 1115
