# Access Compliance Report Public Rights-of-Way (Curb Ramps)

Main Street: WEATHERBY\_RD Cross Street: HARRISBURG\_RD Location: SW

ADA ID: RPRK211215115458 Ramp Type: Type 1 - Perpendicular Diagonal Initial Pass/Fail: Fail Overall Compliance: No Severity Score: 15

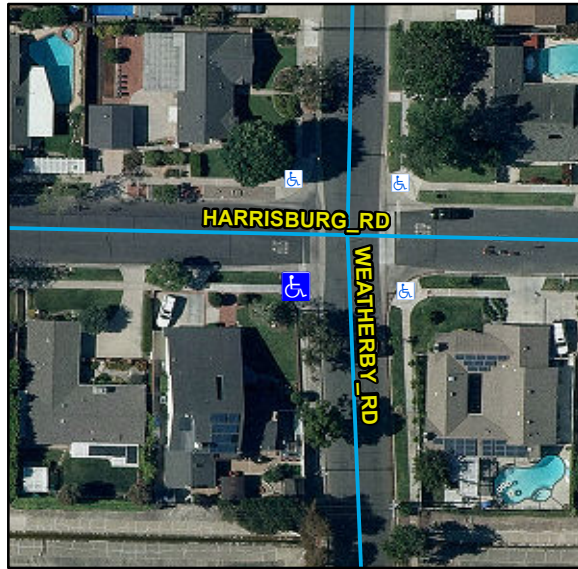
R304.2.2, R204.3, R302.7.2, STD 1115

| Compliance | Description | Data | Compliance | Description | Data |
|---|---|---|---|---|---|
| No | Ramp Run Slope (%) | 8.7 | N/A | Flare Slope LT (%) | N/A |
| No | Gutter Lip Height (in) | 0.25 | | Road Run Slope (%) | 0.5 |

Remove & Replace Curb Ramp With Two New Directional Ramps or Equivalent.

Total Cost: \$ 6160
