# Access Compliance Report Public Rights-of-Way (Curb Ramps)

| Main Street: WALLINGSFORD_RD | Cross Street: HARRISBURG_RD | Location: NE |

| ADA ID: RPRK211215115808 | Ramp Type: Type 1 - Perpendicular Diagonal Initial Pass/Fail: Pass | Overall Compliance: No | Severity Score: 12 |

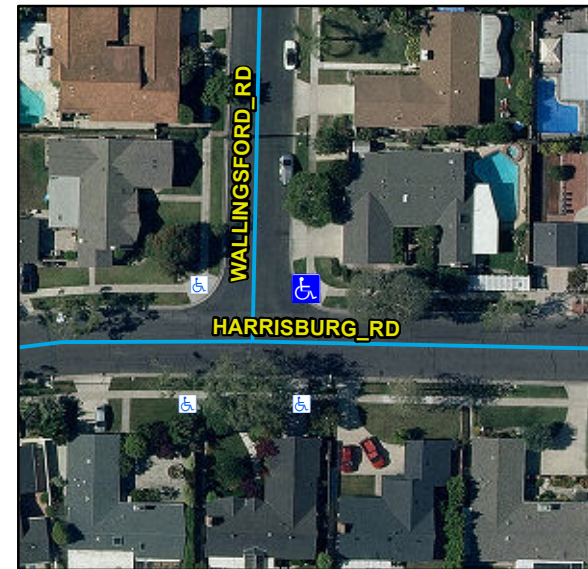
| R304.2.2, R204.3, R304.2.2-Perp, R304.3.2-Para, R305, R302.7, STD 1115 |

| Remove & Replace Curb Ramp With Two New Directional Ramps or Equivalent. |

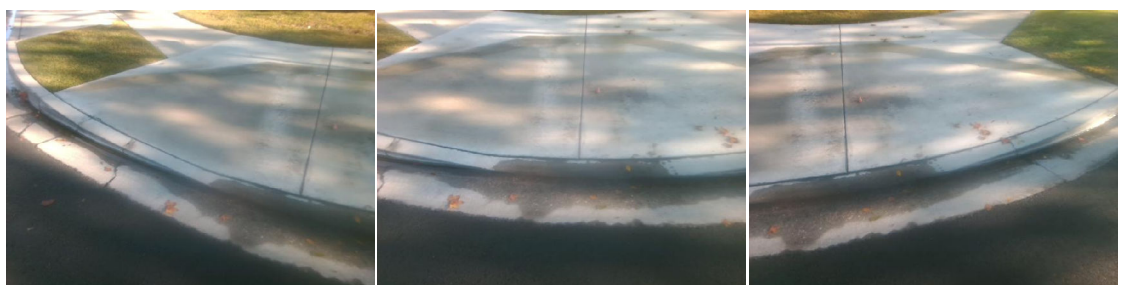
| Compliance | Description | Data | Compliance | Description | Data |
|---|---|---|---|---|---|
| No | Landing Run Slope (%) | 3.5 | N/A | Flare Traversable RT | No |
| Yes | Landing Cross Slope (%) | 2 | No | DWS Provided | No |
| No | Gutter Ponding | Yes | No | Curb Slope | 9.6 |
