# Access Compliance Report Public Rights-of-Way (Curb Ramps)

Main Street: HARRISBURG\_RD Cross Street: PEMBERTON\_RD Location: NW

ADA ID: RPRK211215120718 Ramp Type: Type 1 - Perpendicular Diagonal Initial Pass/Fail: Fail Overall Compliance: No Severity Score: 15

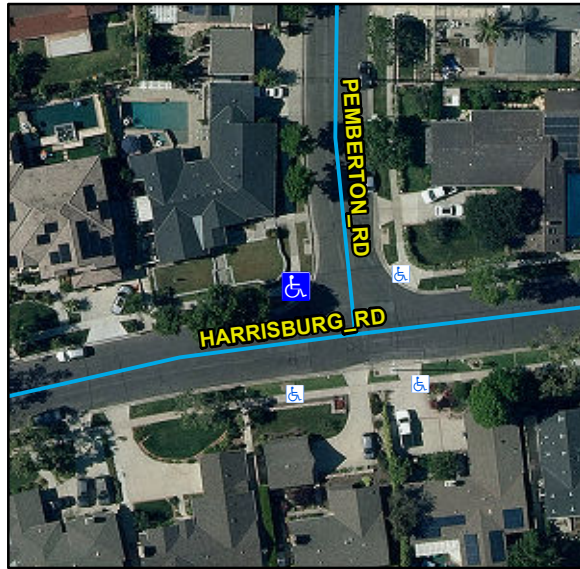
| Compliance | Description | Data | Compliance | Description | Data |
|---|---|---|---|---|---|
| No | Ramp Run Slope (%) | 8.4 | N/A | Flare Slope LT (%) | N/A |

**Remove & Replace Curb Ramp With Two New Directional Ramps or Equivalent.**
