# Access Compliance Report Public Rights-of-Way (Curb Ramps)

Main Street: PEMBERTON\_RD Cross Street: DRYSDALE\_LN Location: SW

ADA ID: RPRK211215121105 Ramp Type: Type 1 - Perpendicular Diagonal Initial Pass/Fail: Fail Overall Compliance: No Severity Score: 15

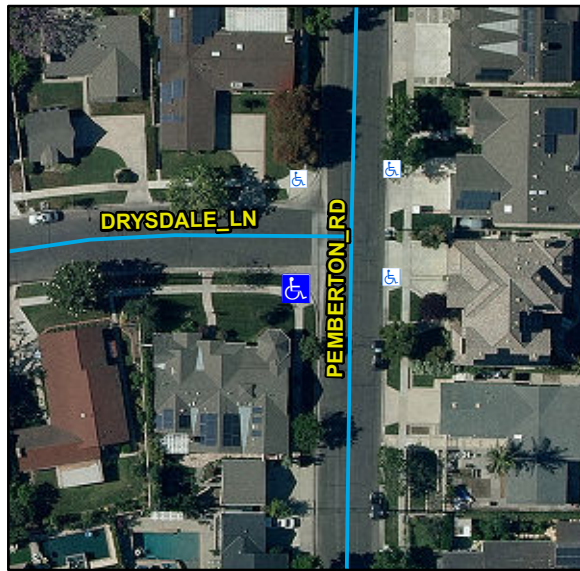
| Compliance | Description | Data | Compliance | Description | Data |
|---|---|---|---|---|---|
| No | Ramp Run Slope (%) | 8.7 | N/A | Flare Slope LT (%) | N/A |

Remove & Replace Curb Ramp With Two New Directional Ramps or Equivalent.

R304.2.2, R204.3, STD 1115
