# Access Compliance Report Public Rights-of-Way (Curb Ramps)

Main Street: DRYSDALE\_LN Cross Street: PEMBERTON\_RD Location: NW

ADA ID: RPRK211215121231 Ramp Type: Type 1 - Perpendicular Diagonal Initial Pass/Fail: Fail Overall Compliance: No Severity Score: 15

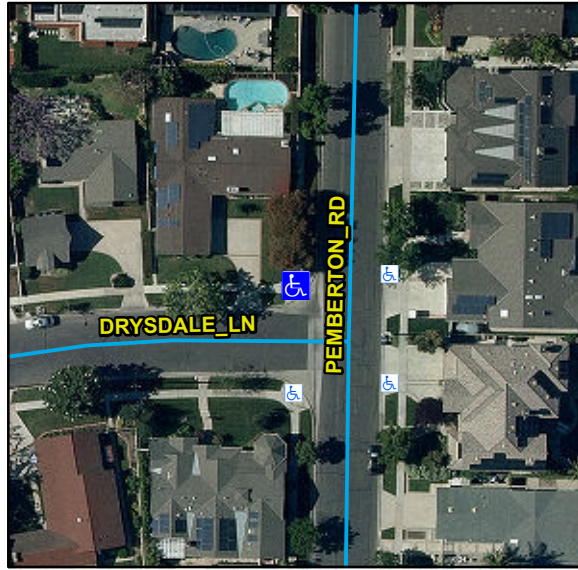
| Compliance | Description | Data | Compliance | Description | Data |
|---|---|---|---|---|---|
| No | Ramp Run Slope (%) | 9.6 | N/A | Flare Slope LT (%) | N/A |

**Remove & Replace Curb Ramp With Two New Directional Ramps or Equivalent.**

**R204.3, R304.2.2, STD 1115**
