# Access Compliance Report Public Rights-of-Way (Curb Ramps)

Main Street: DRYSDALE\_LN Cross Street: BASKERVILLE\_RD Location: S

ADA ID: RPRK211215122126 Ramp Type: Type 1 - Perpendicular Diagonal Initial Pass/Fail: Pass Overall Compliance: No Severity Score: 12

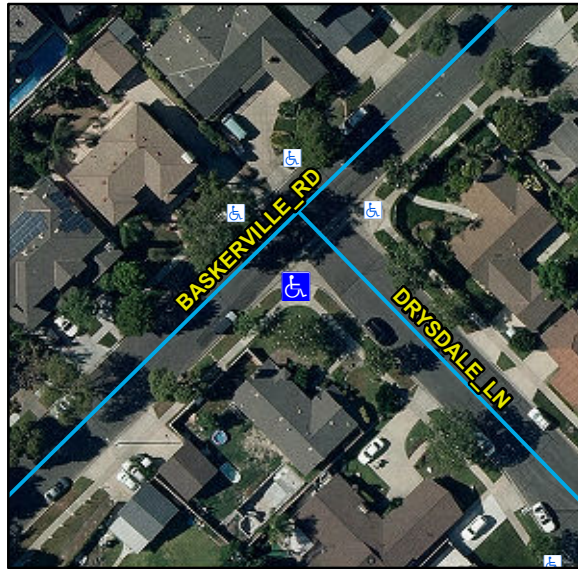
| Compliance | Description | Data | Compliance | Description | Data |
|---|---|---|---|---|---|
| No | Landing Run Slope (%) | 3.8 | N/A | Flare Traversable RT | No |
| Yes | Landing Cross Slope (%) | 0.1 | No | DWS Provided | No |

Remove & Replace Curb Ramp With Two New Directional Ramps or Equivalent.
