# Access Compliance Report Public Rights-of-Way (Curb Ramps)

| Main Street: BASKERVILLE_RD | | Cross Street: DRYSDALE_LN | | Location: | SE |
| ADA ID: RPRK211215122520 | | Ramp Type:Type 1 - Perpendicular Diagonal Initial Pass/Fail: Pass | | Overall Compliance: No | Severity Score: 10 |

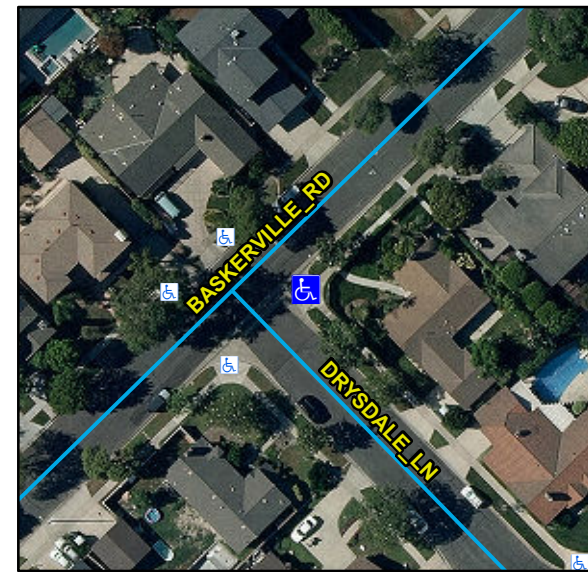
| Compliance | Description | Data | Compliance | Description | Data |
|---|---|---|---|---|---|
| Yes | Landing Cross Slope (%) | 0.8 | No | DWS Provided | No |

**Remove & Replace Curb Ramp With Two New Directional Ramps or Equivalent.**

**R204.3, R305, STD 1115**

Total Cost: \$ 6160
