# Access Compliance Report Public Rights-of-Way (Curb Ramps)

| Main Street: BASKERVILLE_RD | | Cross Street: KERTH_DR | | Location: | S |
| ADA ID: RPRK211215122824 | Ramp Type:Type 1 - Perpendicular | Initial Pass/Fail: Pass | Overall Compliance: No | Severity Score: | 16 |

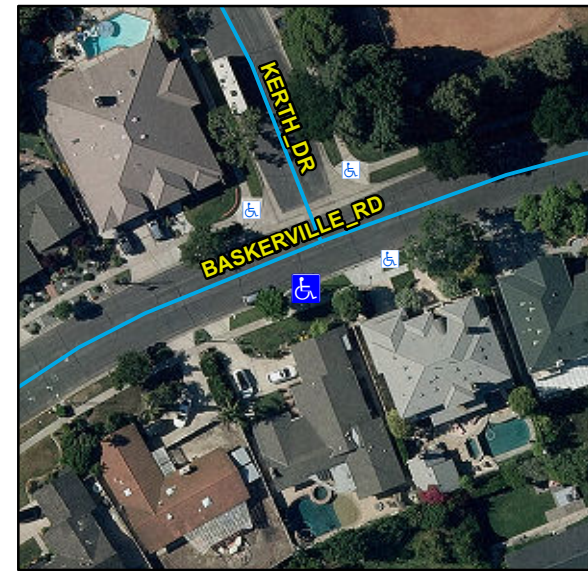
| Compliance | Description | Data | Compliance | Description | Data |
|---|---|---|---|---|---|
| Yes | Landing Cross Slope (%) | 1.7 | No | DWS Provided | No |
| Yes | Gutter Ponding | No | No | Curb Slope | 12.5 |
| No | Gutter Run Slope (%) | 7.7 | | Road Cross Slope (%) | N/A |

Possible Solutions:

**Remove & Replace Entire Ramp. Remove & Replace Gutter.**

**R304.2.2, R305, R304.5.4, STD 1115**
