# Access Compliance Report Public Rights-of-Way (Curb Ramps)

Main Street: BASKERVILLE\_RD Cross Street: KERTH\_DR Location: NW

ADA ID: RPRK211215123241 Ramp Type: Type 1 - Perpendicular Diagonal Initial Pass/Fail: Pass Overall Compliance: No Severity Score: 16

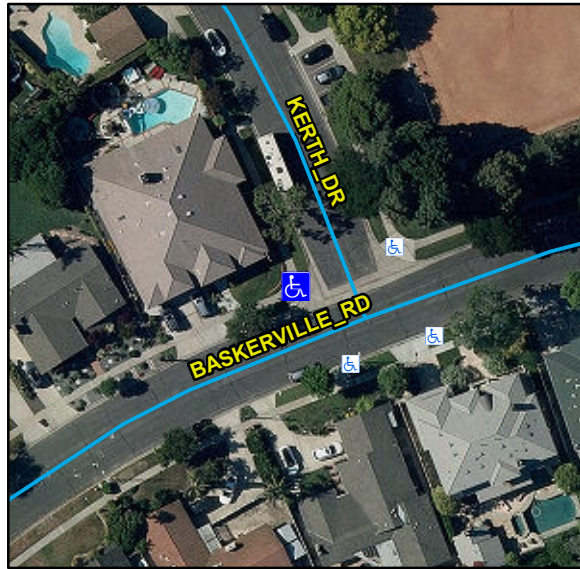
| Compliance | Description | Data | Compliance | Description | Data |
|---|---|---|---|---|---|
| Yes | Landing Cross Slope (%) | 1.8 | No | DWS Provided | No |

Remove & Replace Curb Ramp With Two New Directional Ramps or Equivalent.

R204.3, R304.2.1, R305, STD 1115
